Rice Lake Shoreline Erosion 2015

Surveyed Jan 2015 (during lake drawdown)
By James A. Johnson
Freshwater Scientific Services, LLC

Management Prioritization

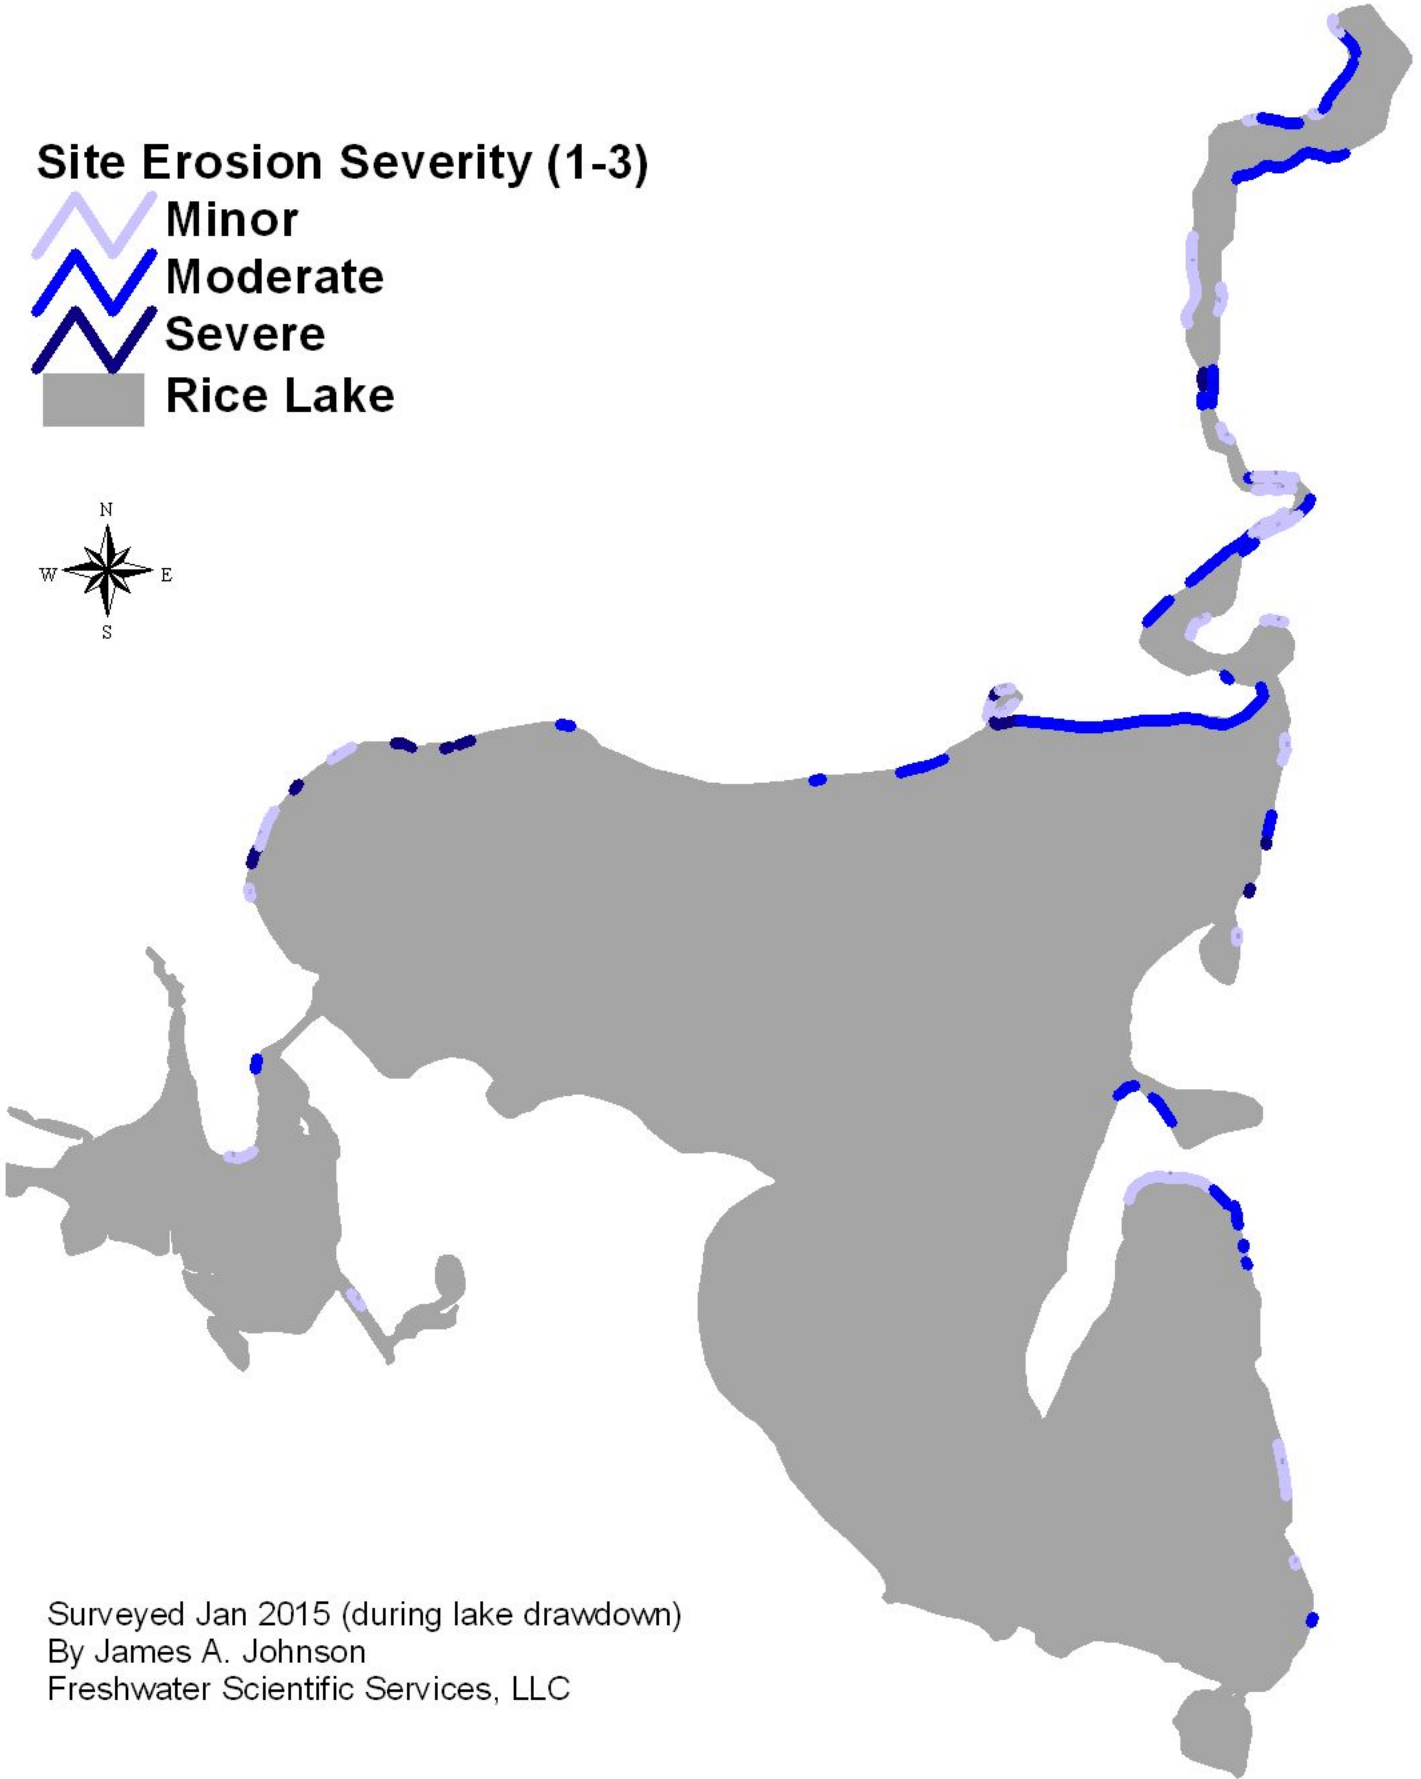
Site Erosion Severity (1-3)

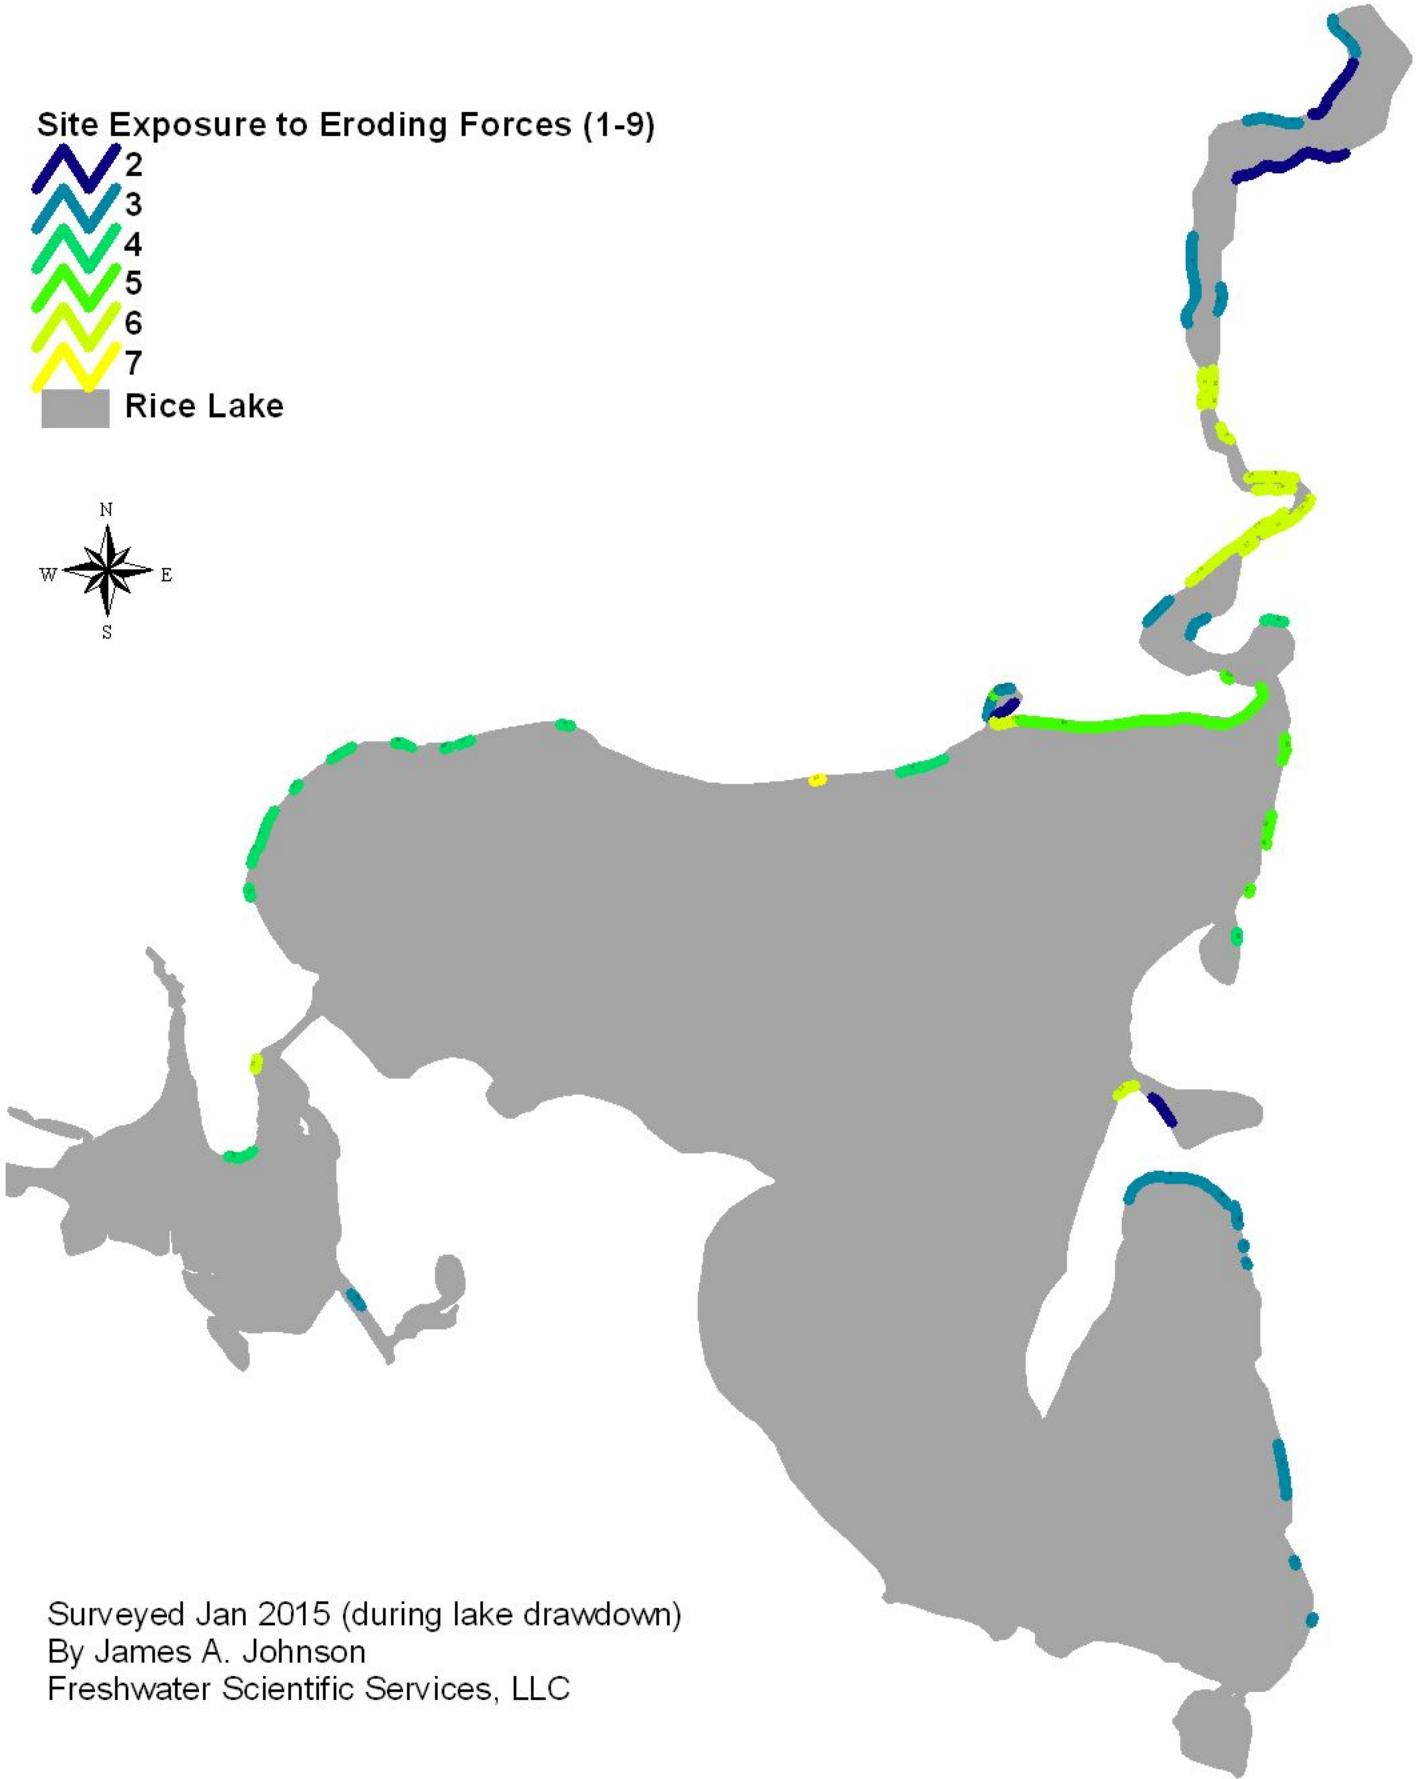
Site Exposure to Eroding Forces (1-9)

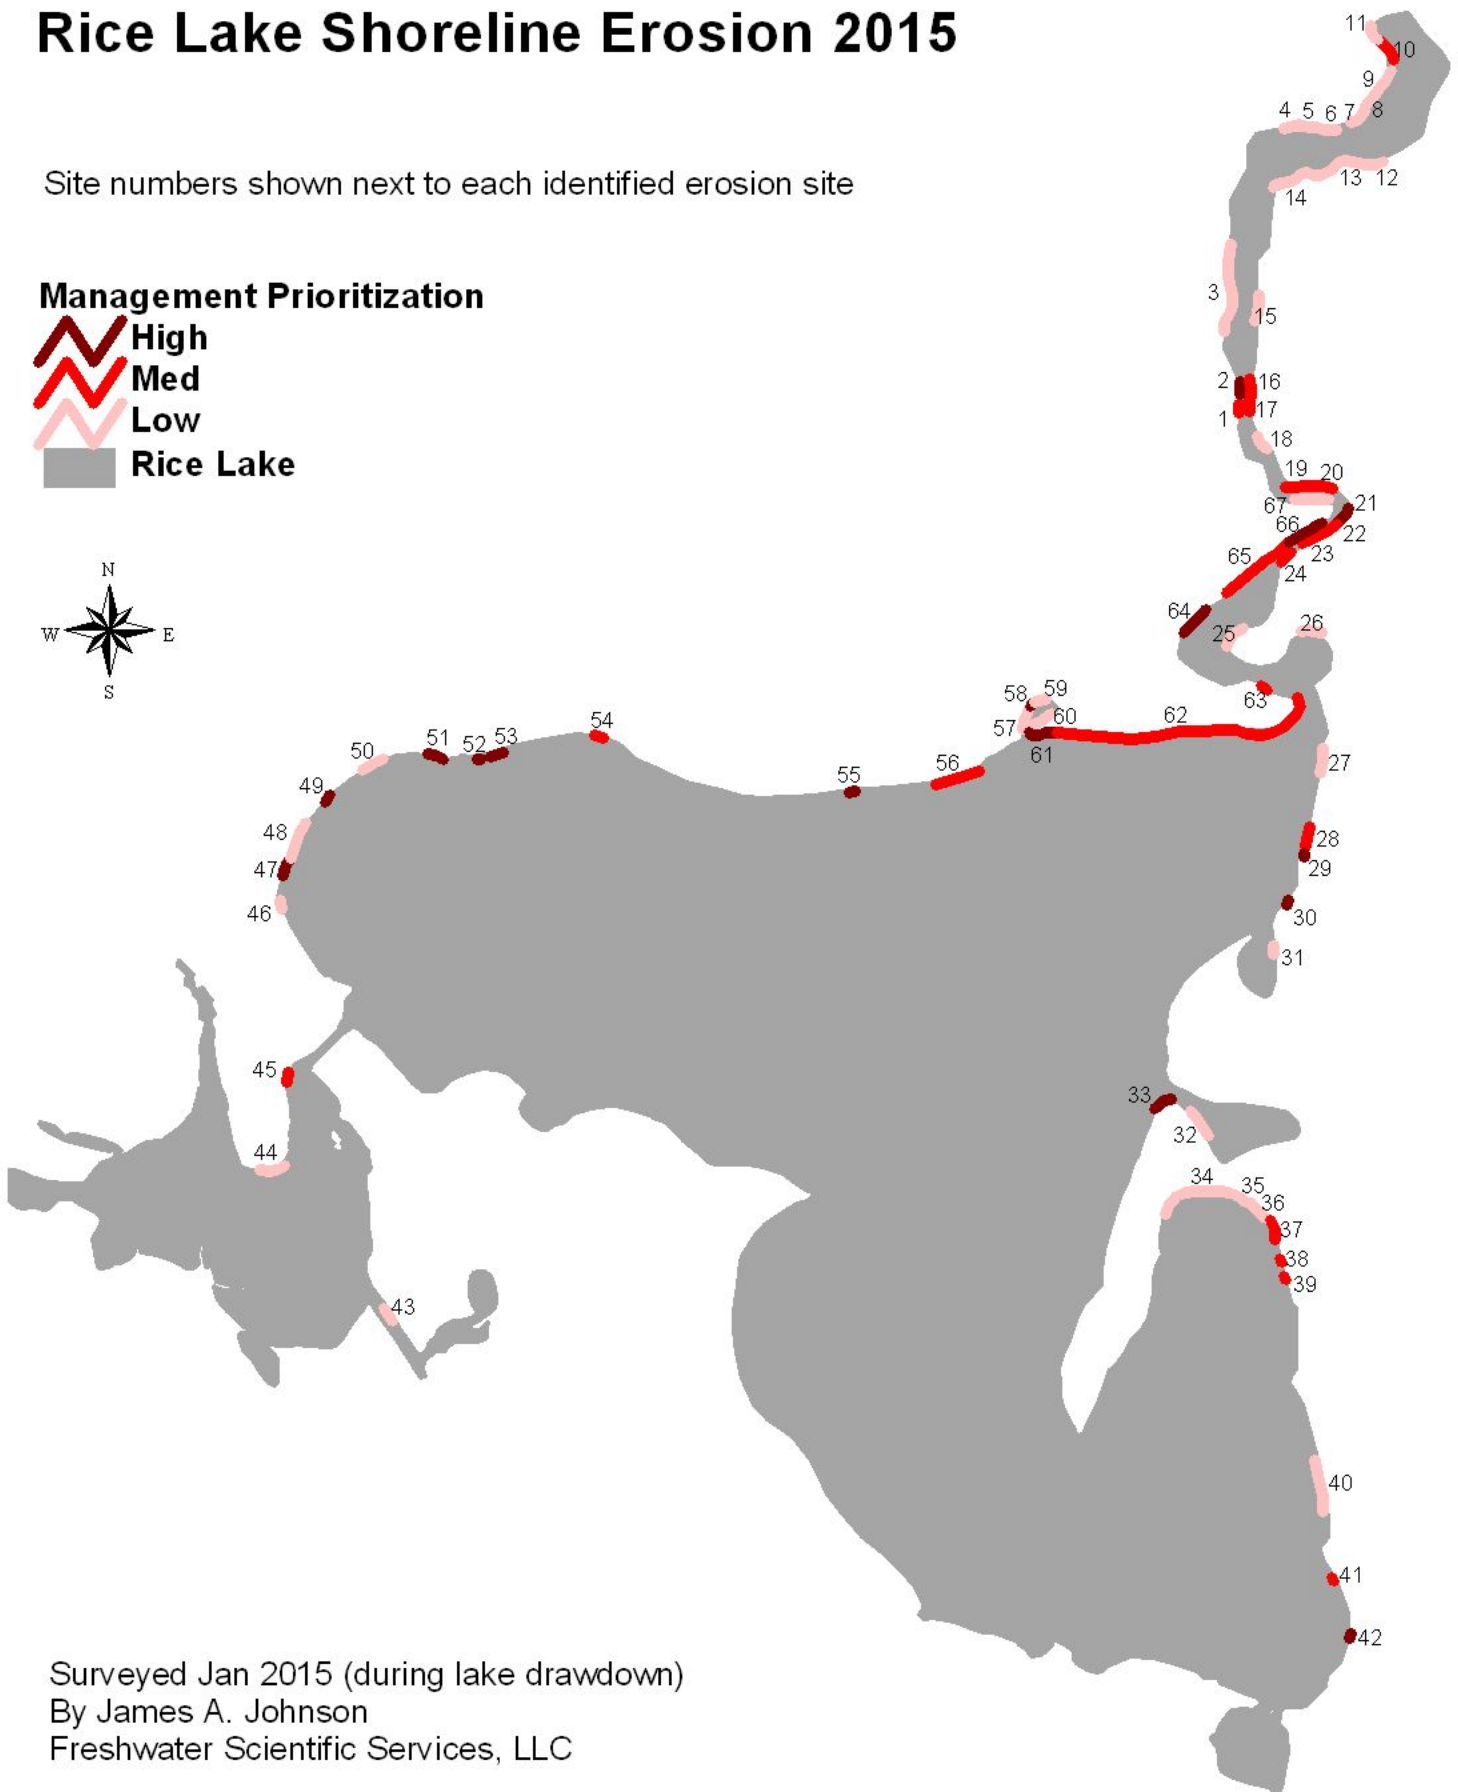
Site numbers shown next to each identified erosion site
